BUREAU OF SHIPS GROUP

TECHNICAL INSPECTION REPORT

USS NEVADA (BB36)

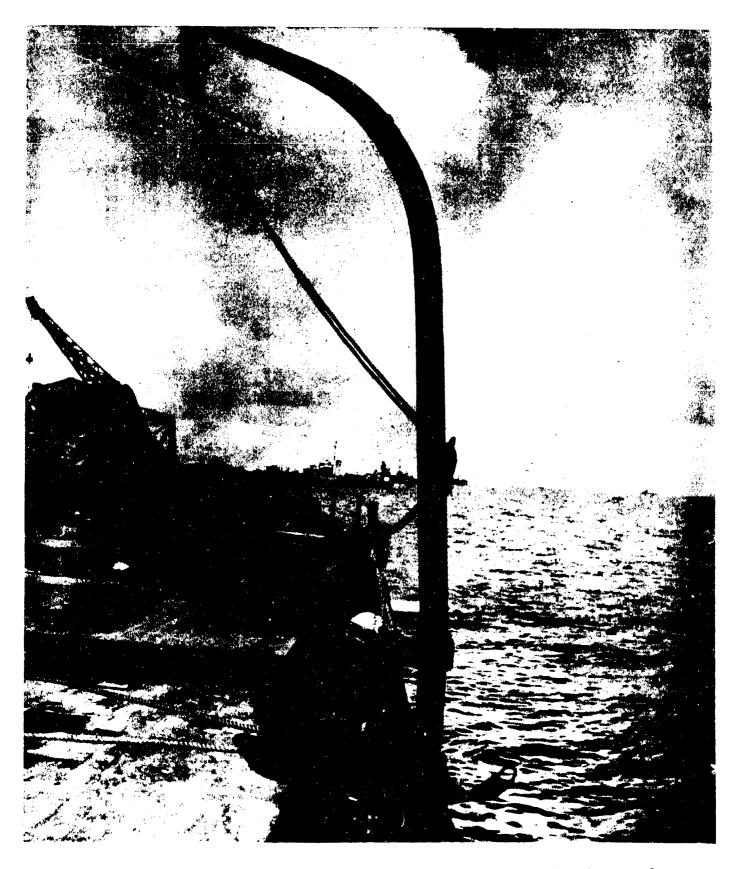
AA-CR-100-1889-8. Port side ladder davit, frame 105, showing bend above deck edge fitting.

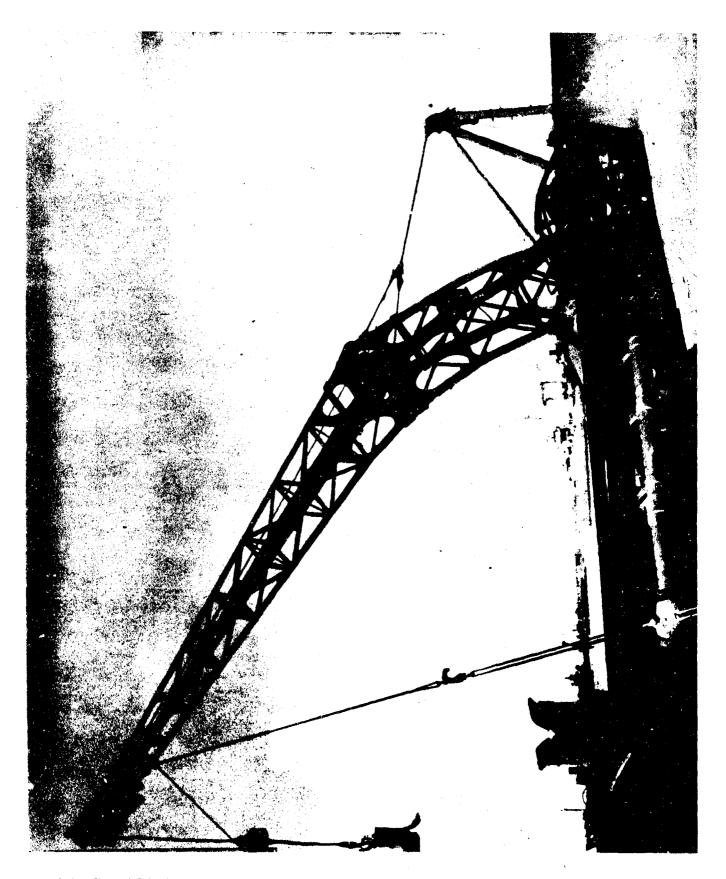
AA-CR-100-1889-9. Stern crane, showing lower section buckled and resting on the catapult. Looking aft and to starboard.

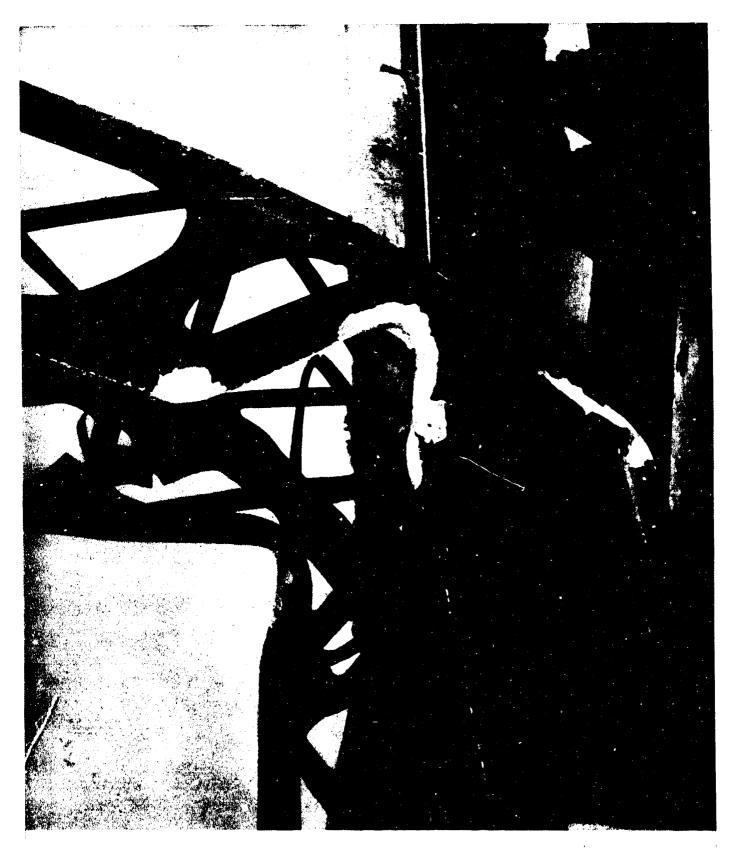
AA-CR-100-1889-12. Detail of failure of lower section of crane.

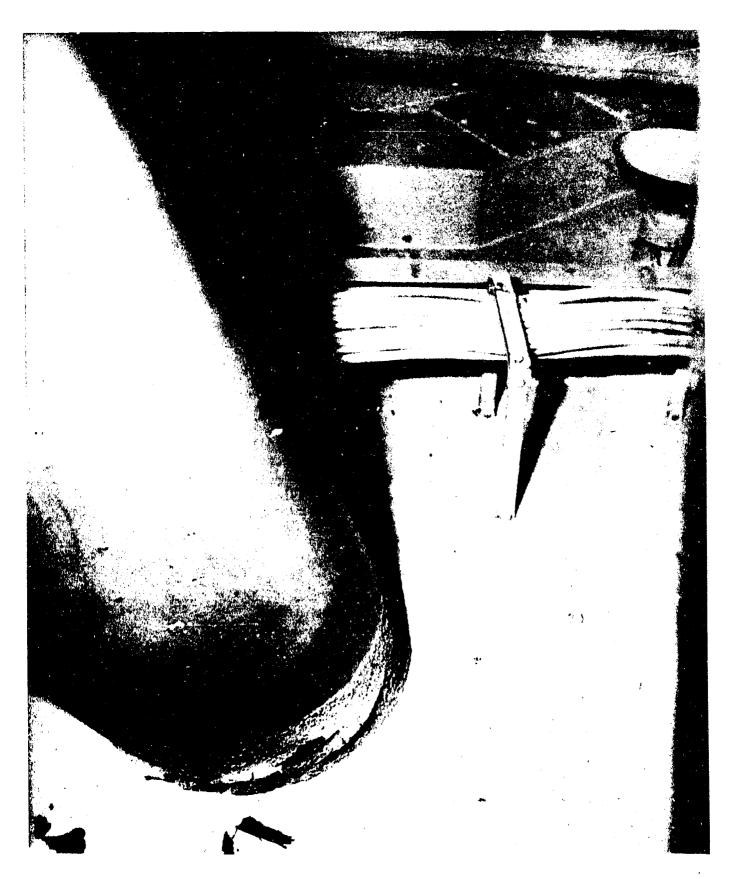
AA-CR-175-2154-2. Crew's space. A-0114L. Upper deck level. Forward leg of port director tub, frame 68-69, looking up and slightly outboard.

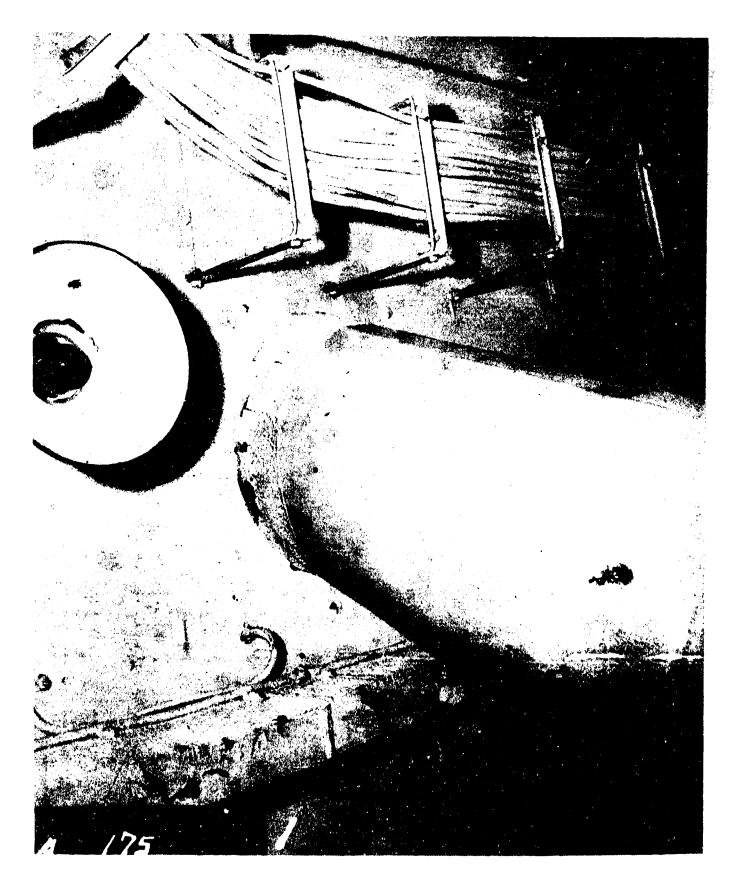
AA-CR-175-2154-1. Crew's space. A-0114L. Upper deck level. Forward leg of port director tub, frame 68-69, looking inboard, showing compression evidence at top of leg.

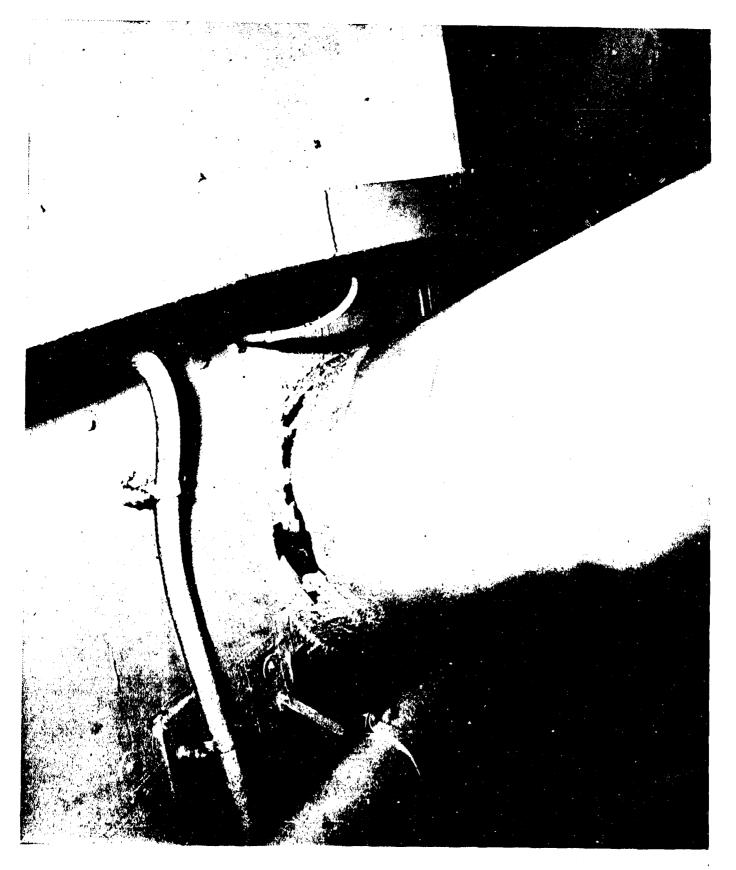
AA-CR-175-2137-10. Crew's space. A-0114L. Upper deck level. Forward leg of starboard director tub, frame 68-69, looking inboard and slightly aft. Showing compression evidence at top of leg and twist in beam at frame 68.

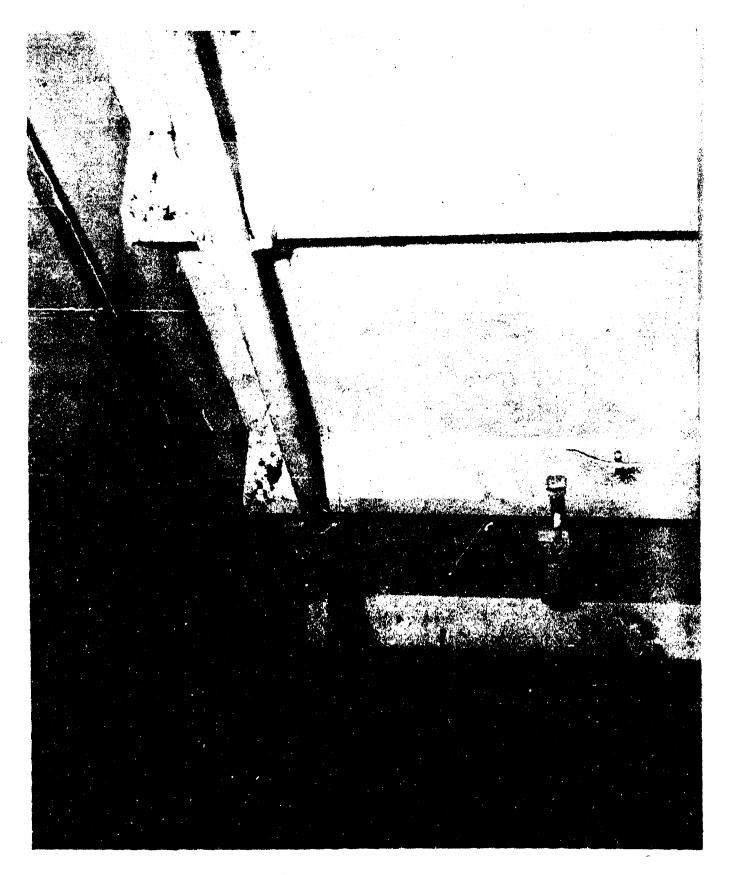
AA-CR-175-2154-5. Crew's space. A-Q114L. Deck beams under 02 level, frames 66, 67 and 68, at longitudinal bulkhead, 8 feet off center-line to starboard, looking aft.

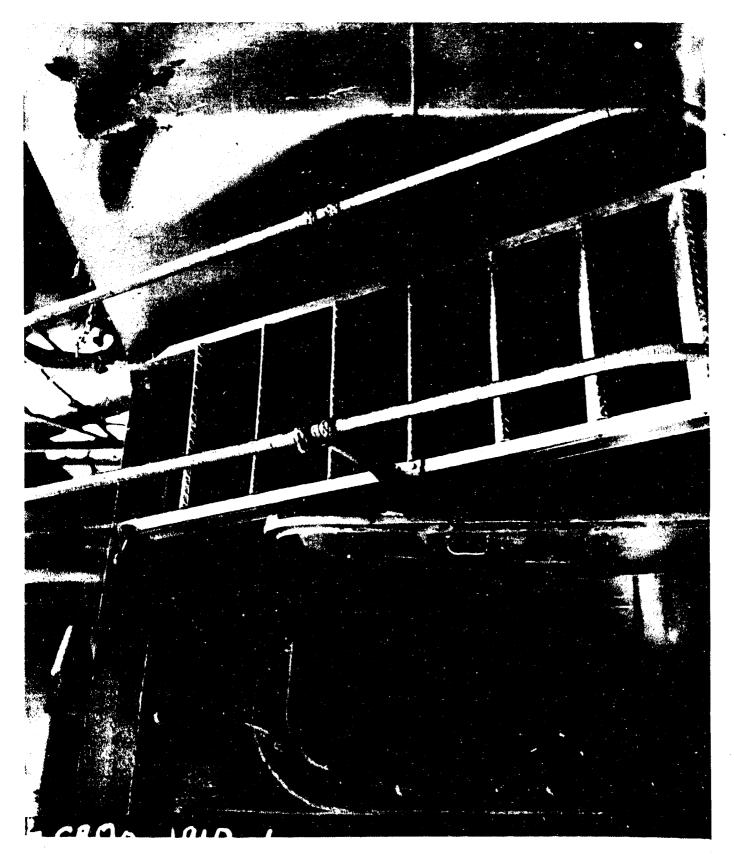
AA-CR-80-1910-1. Looking aft and inboard at starboard side of transverse bulkhead 61 on upper deck. Note that overhead has been slightly depressed buckling the bulkhead and door.

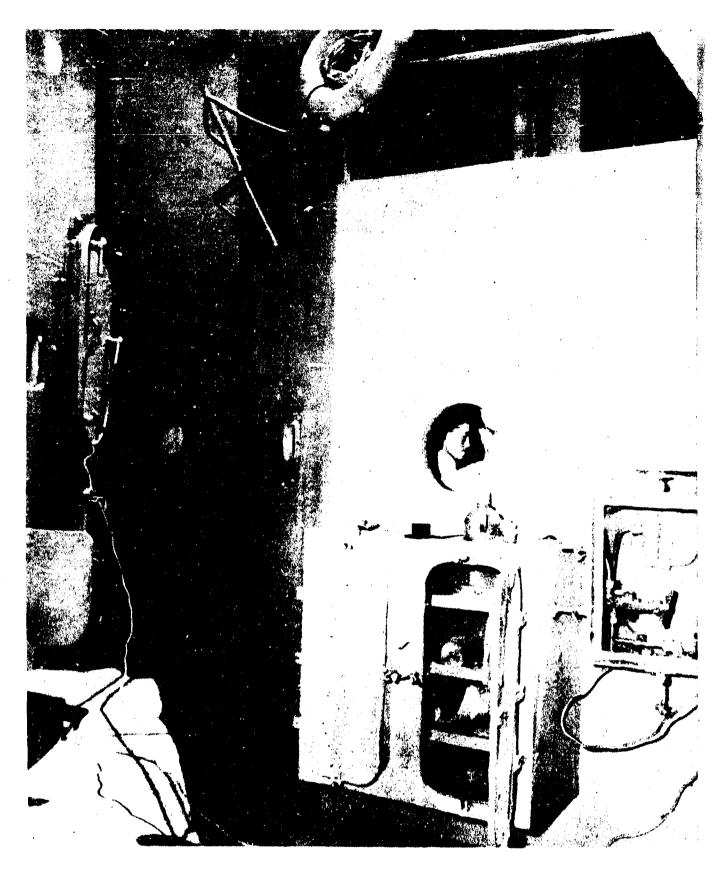
AA-CR-80-1910-3. Looking aft and inboard from frame 78 on starboard side of upper deck.

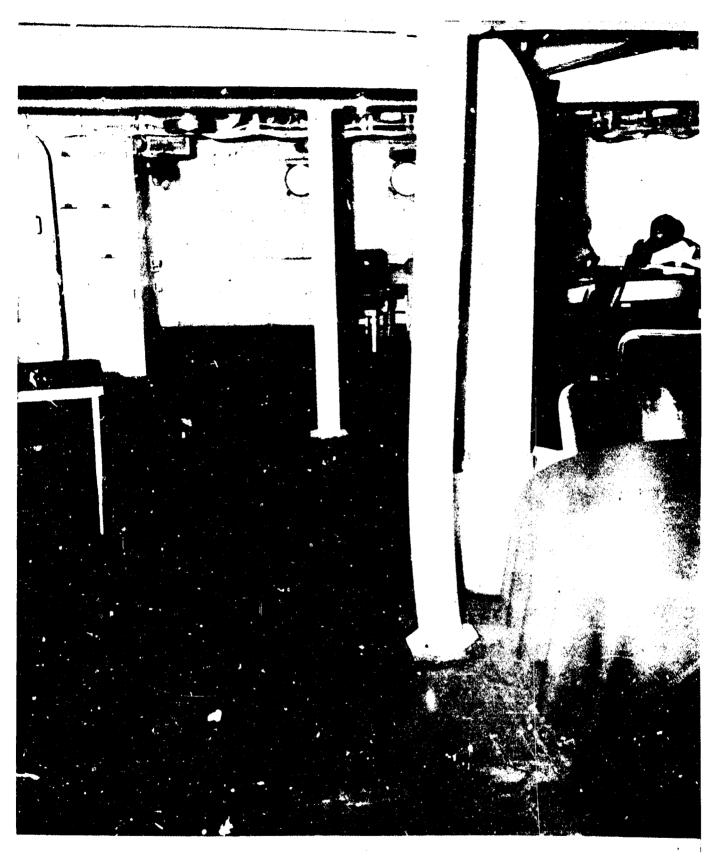
AA-CR-175-2155-7. Wardroom. A-126-L. Local deflection of main deck in way of centerline and port stanchion, frame 28.

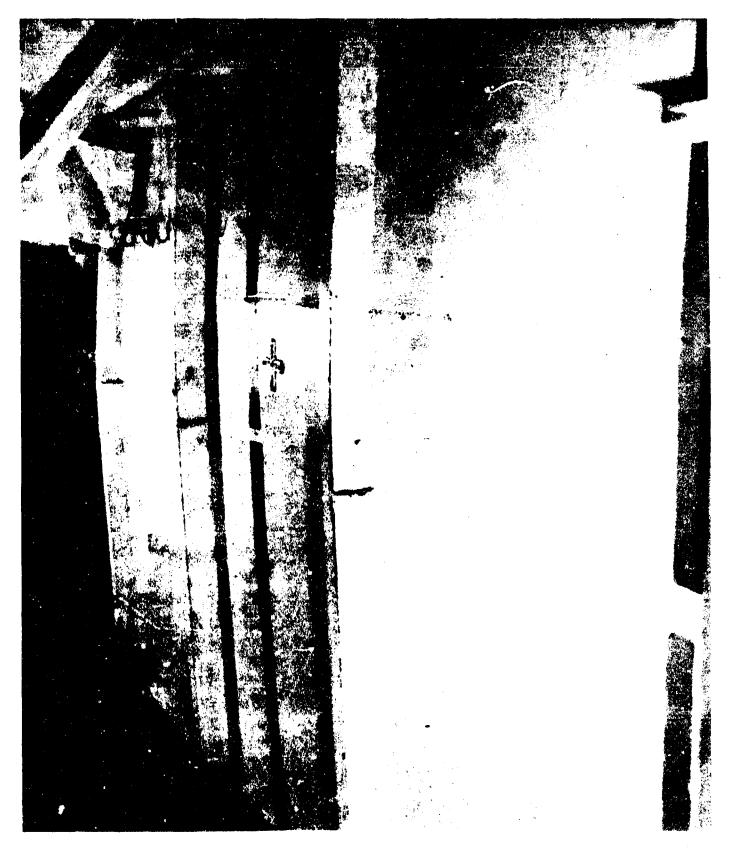
AA-CR-175-2136-6. Crew's berthing, D-201-4L, 2nd deck. Looking to port from centerline at buckle in aft face of bulkhead 97.

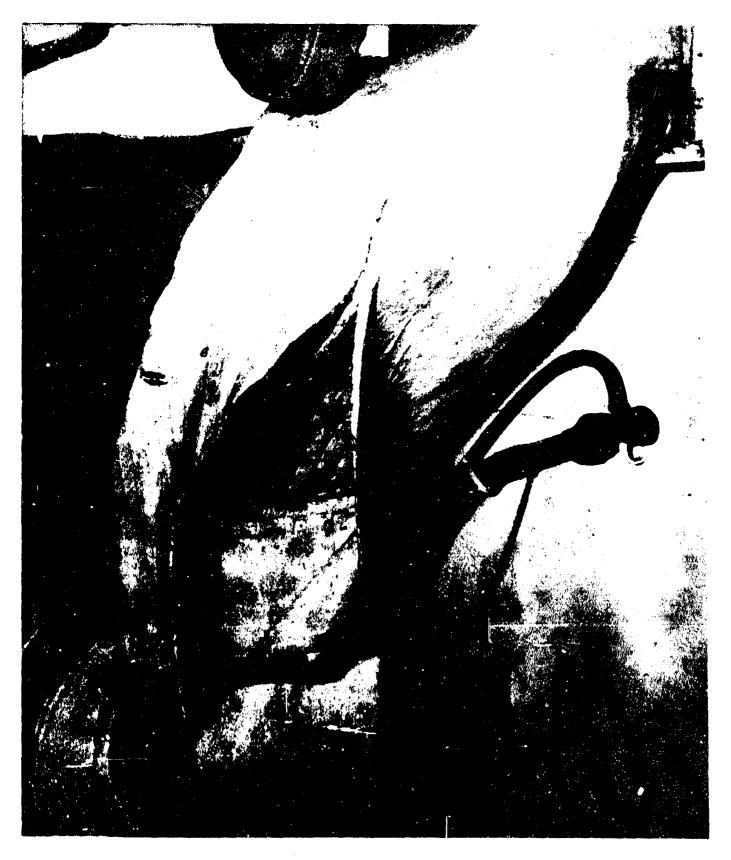
AA-CR-175-2136-4. Compartment C-291-1L. Looking forward and to port on second deck at damaged ventilation duct through starboard side of bulkhead 85.

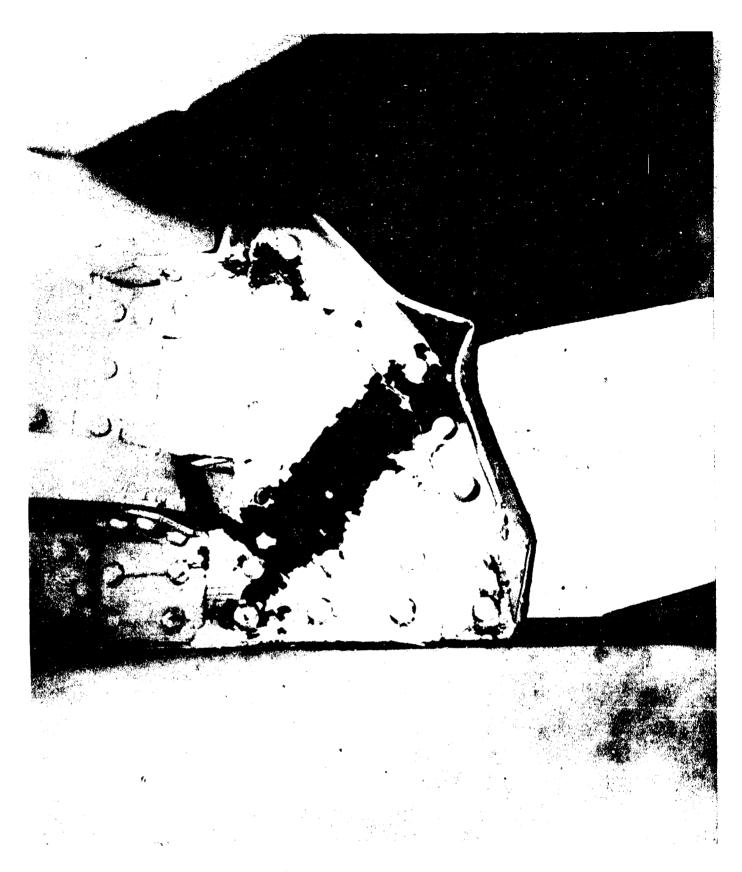
AA-CR-175-2136-3. Crew's berthing, D-203-1L, 2nd deck, looking at port face of centerline bracket connecting main deck girder to after face of No. 4 barbett frame 116 1/2.

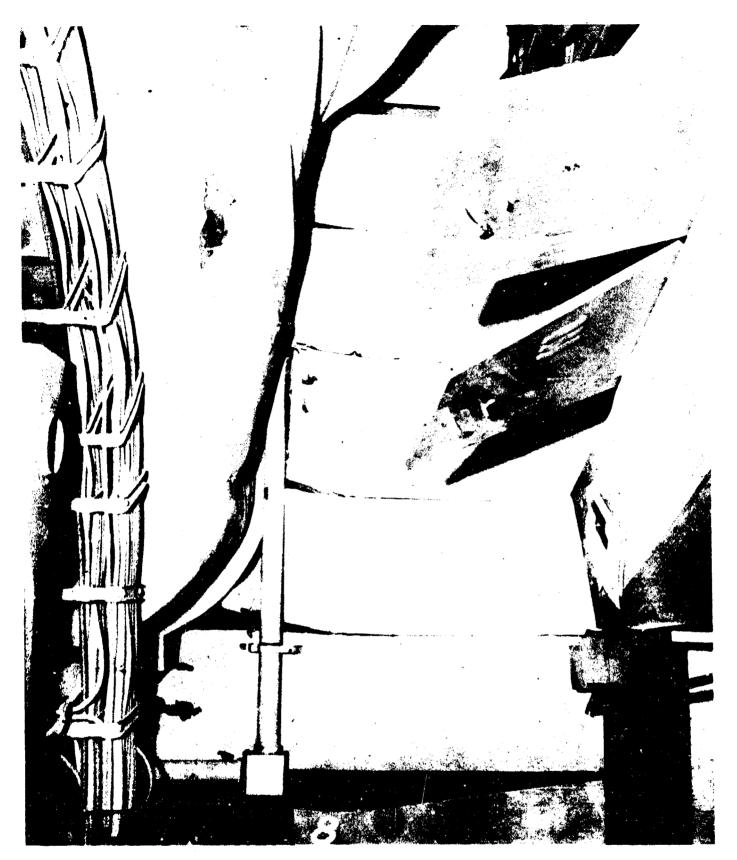
AA-CR-175-2136-8. Tailor shop (ex-library), C-291-1L, 2nd deck, damage to light joiner bulkhead, frames 94 to 97 looking to starboard from centerline.

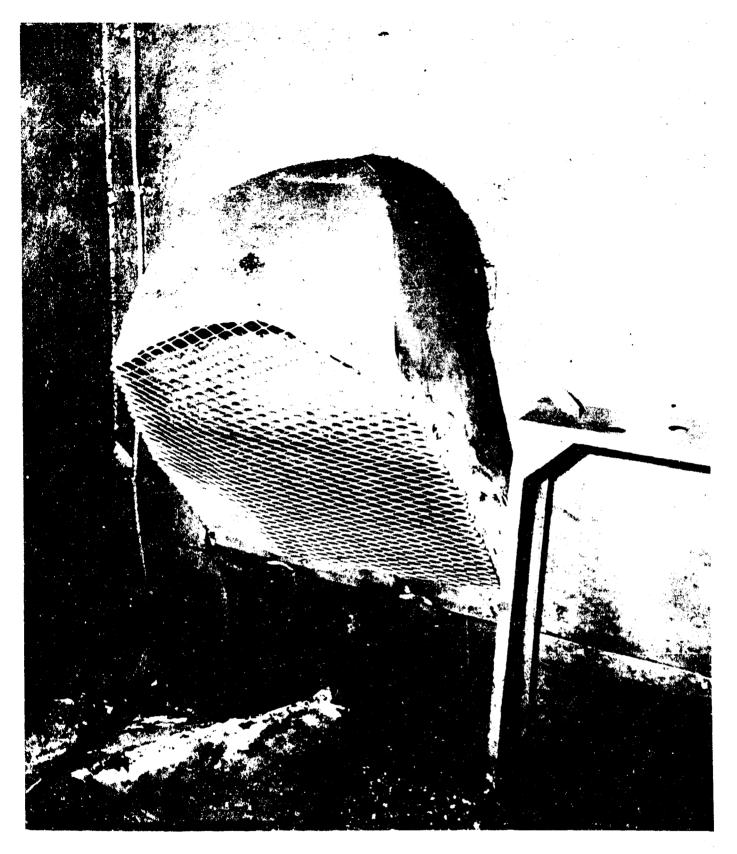
AA-CR-80-1910-4. Damaged ventilator trunk on superstructure deck at frame 87, starboard side. Ships force repair had been made when picture was taken.

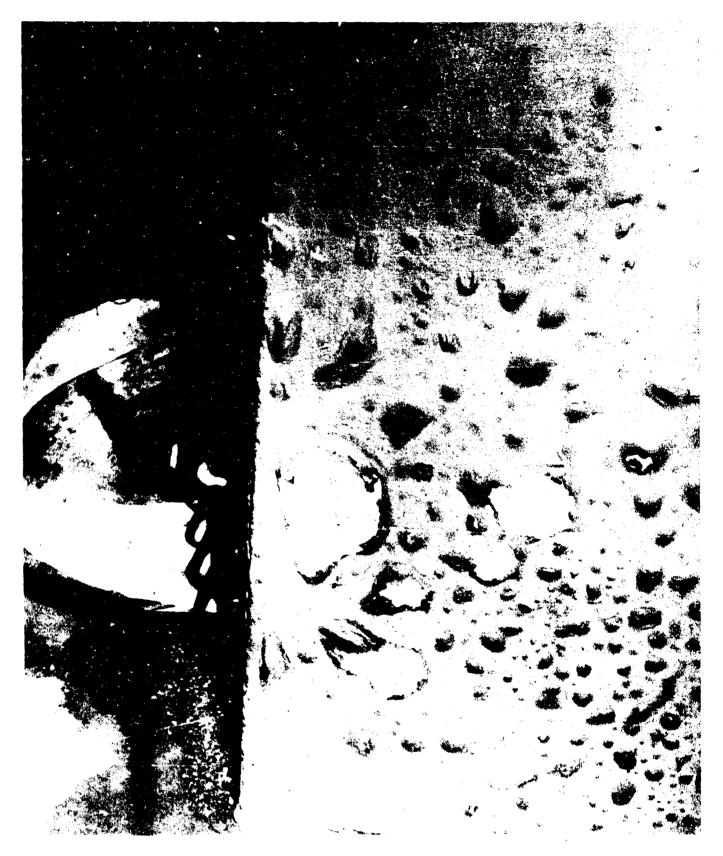
AA-CR-65-1743-6. Damage to paint on face of a bulkhead facing forward.

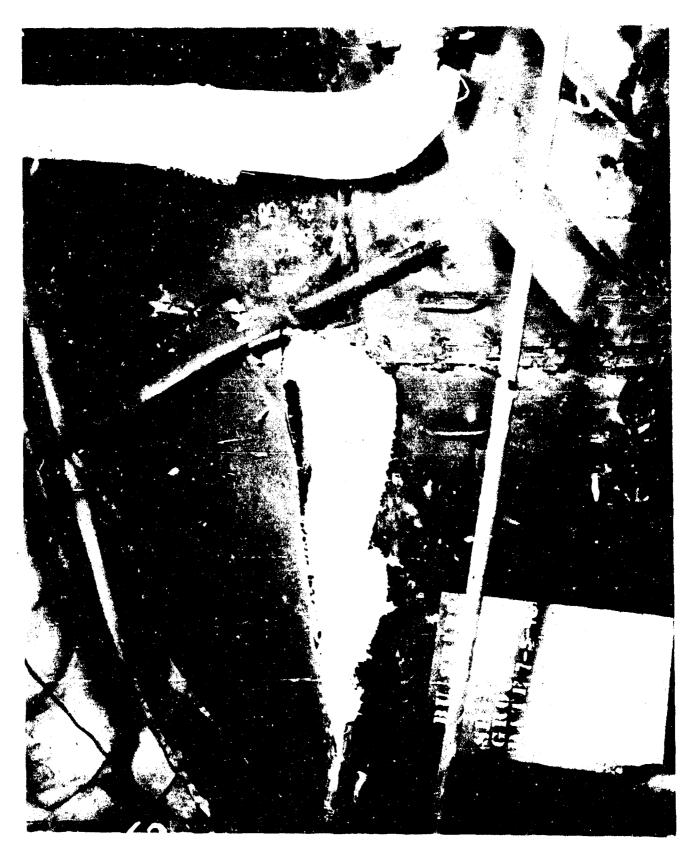
AA-CR-62-1875-7. No. 6 boiler, left side casing panel.

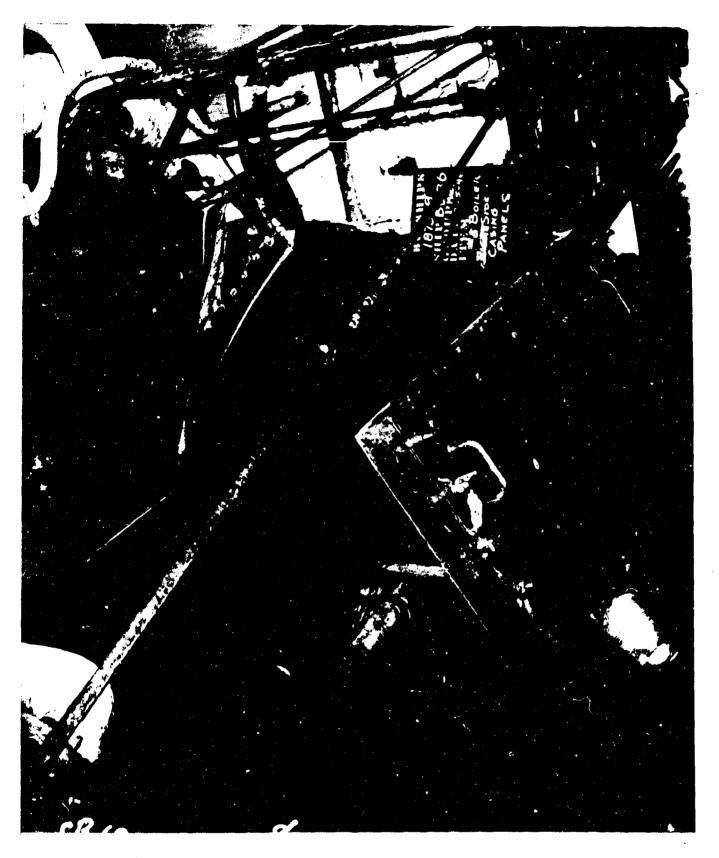
AA-CR-62-1875-8. No. 5 boiler, right side casing panel.

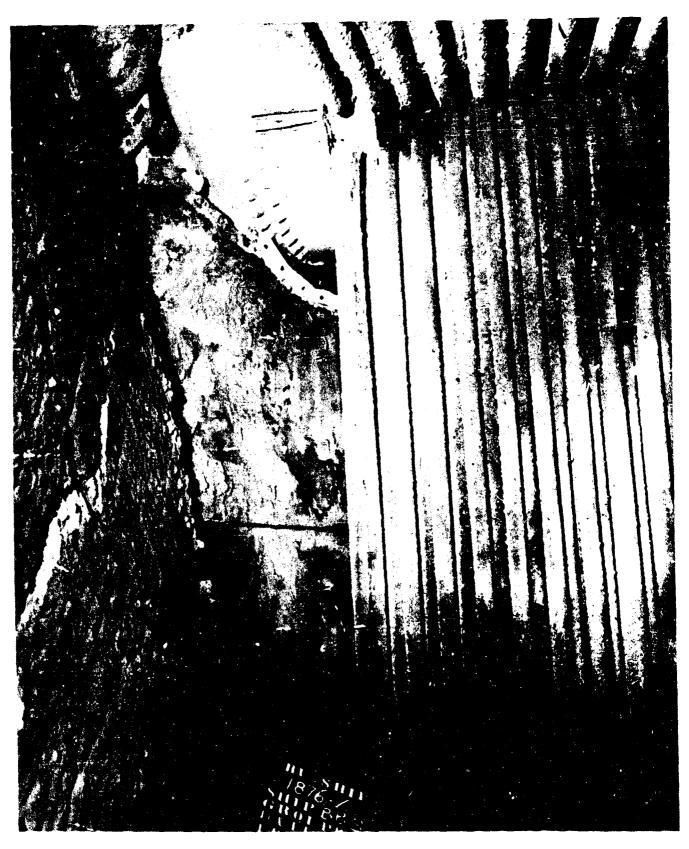
AA-CR-62-1876-1. No. 4 boiler, rear wall near steam drum and tubes.

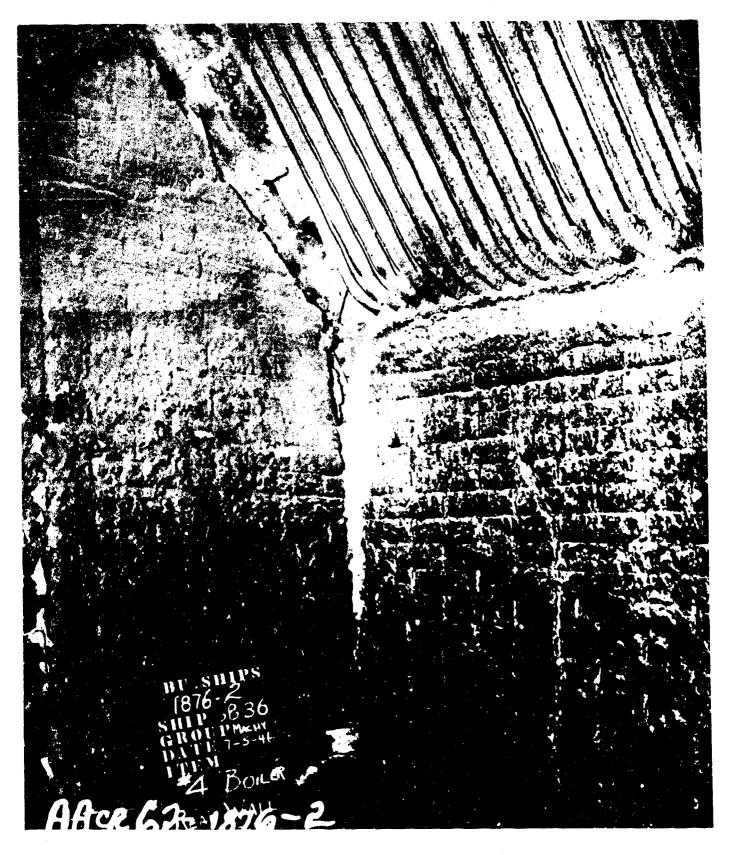
AA-CR-62-1876-2. No. 4 boiler, rear wall near sidewall, right.
